HERDIZ Construction Inc

Repair of clinker oven support tracks

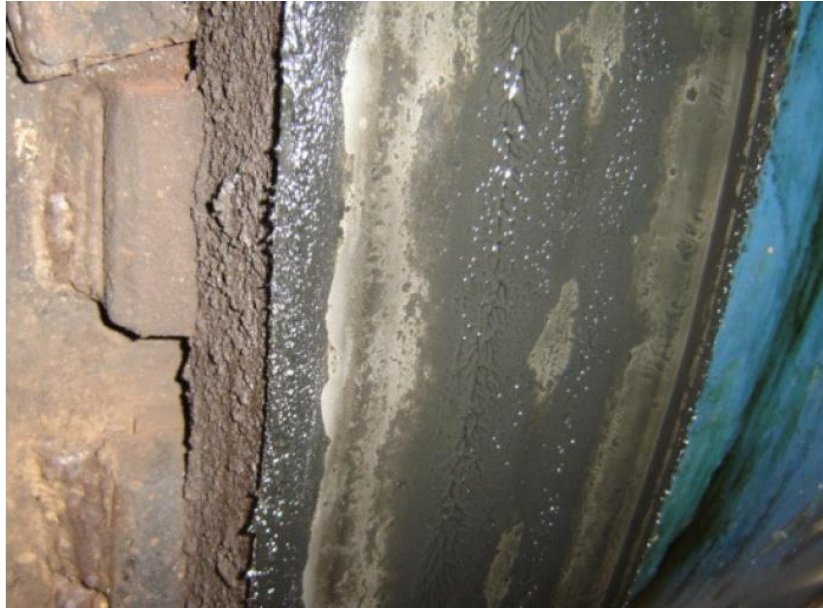
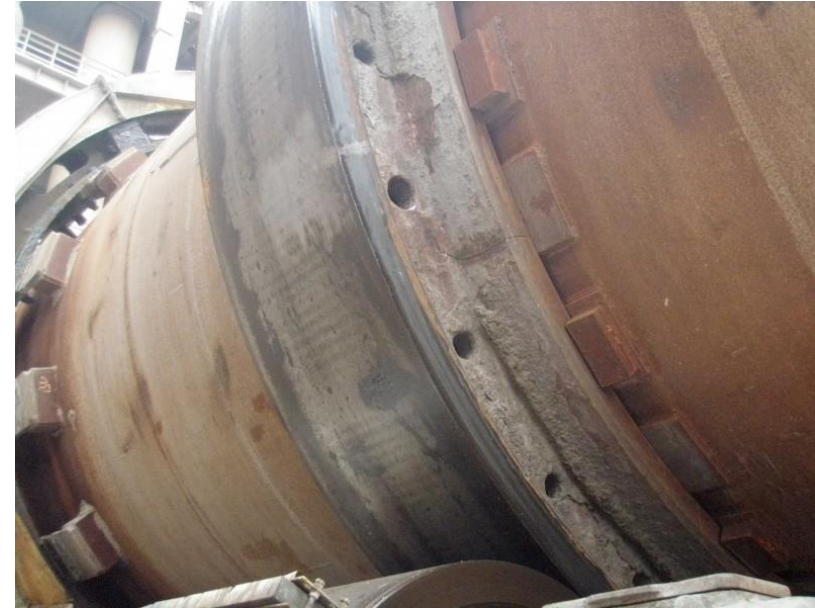
When Rotary drums have several years of continuous work on the tracks or wheels form parallel stripes and valleys to cause vibrations, by loosening screws anchor, they break the bases of the foundations, loosen the refractory interiors, as well as wear and tear sliding, fatigue of material, pitting corrosion, misalignment between other damage.

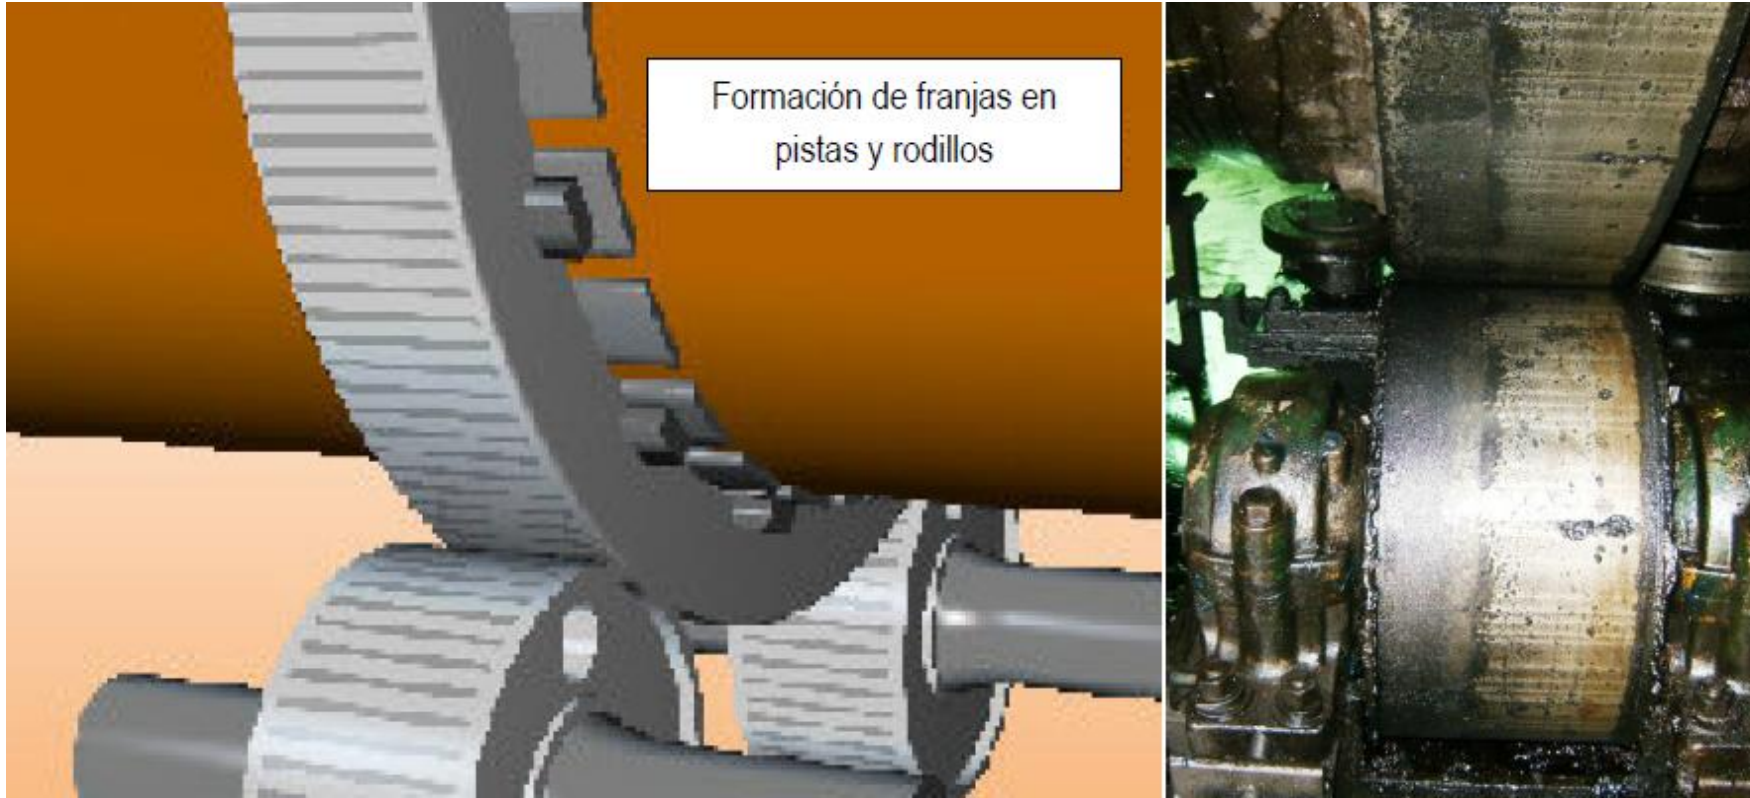
Almost always damage formation of strips this present on tracks or wheels and rollers simultaneously

Mechanization and advanced welding technologies allow to repair these defects extending the life without the need to change tires and make large dismantling. These modern repair processes do not require dismantling wheels or rotate the oven during the welding process
